Fire at the Urban Wildland Interface:

Performance of California Homes and Buildings

Prepared for:
California Department of Forestry and Fire Protection
Attn: Rodney Slaughter, Deputy State Fire Marshal

Prepared by:
Fire Cause Analysis
213 W. Cutting Blvd
Richmond CA 94804
Attn: Joseph Zicherman, Ph.D., SFPE.

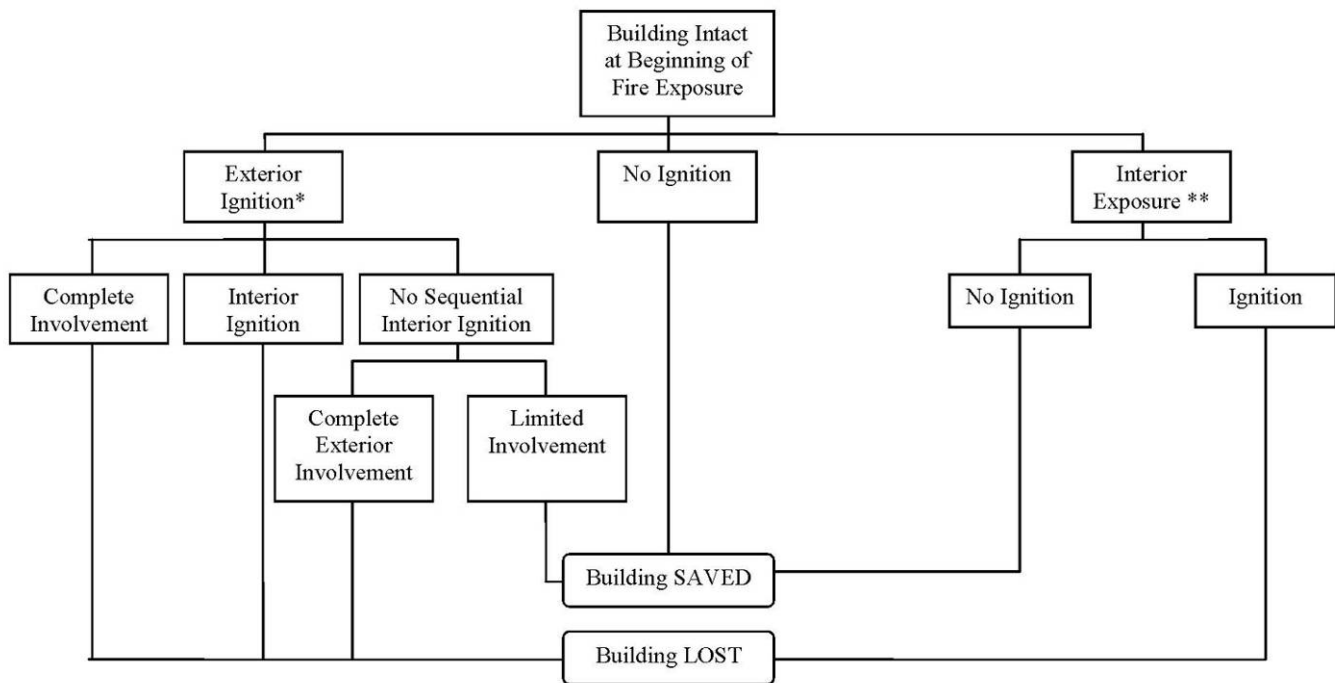
- 1) A building may ignite on the outside and burn essentially from the outside in.
- 2) A building may ignite on the inside from an exterior source– but not on the outside.
- 3) A building may ignite on the outside and fire spread to the inside through eave vents to an attic or by glazing being compromised and an interior fire developing.

Figure 2: Residential Building Failure Modes.

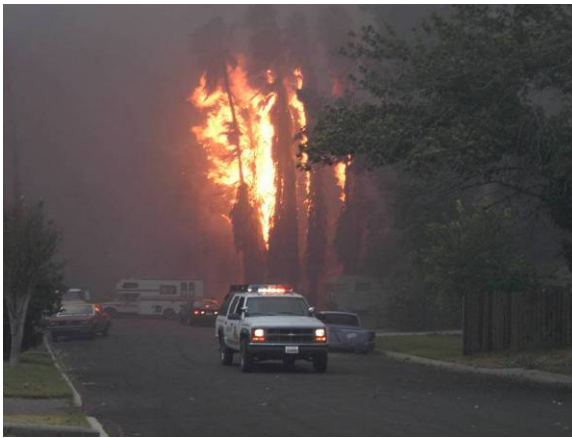
Figure 9: Wind-driven fire in urban setting. Delmar in the fall 2003 fire. [Photo courtesy of R. Crawford.]

Another aspect of construction in San Diego County of interest is the performance of older neighborhoods designed to meet earlier versions of model building codes which do not address fire safety in UWI areas. The effects of such fires have been conflagrations; examples of these include the conflagration in Del Mar California, pictured in figure 9, as well as the urban fire spread through affected homes in the Oakland Hills fire over a decade ago.

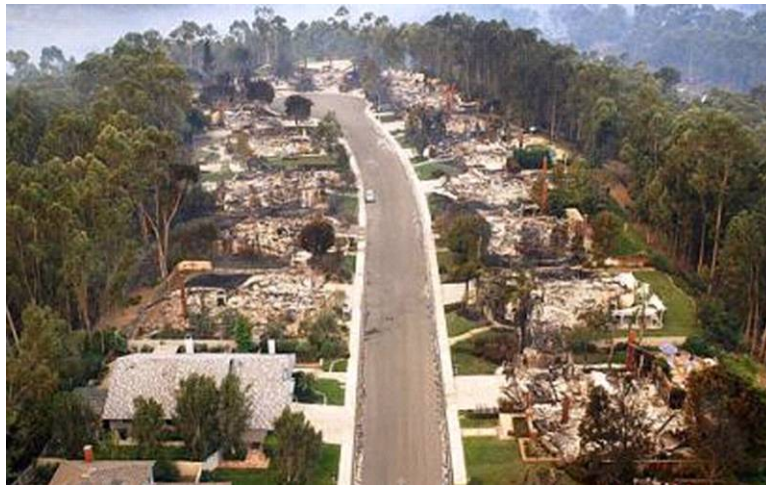
Figure 16: Cul de sac location in greater San Diego following 2003 fire. Note continuity and essentially unburned condition of green belt surrounding burned homes demonstrating house to house spread independent of landscape conditions. Photo US News and World Report.

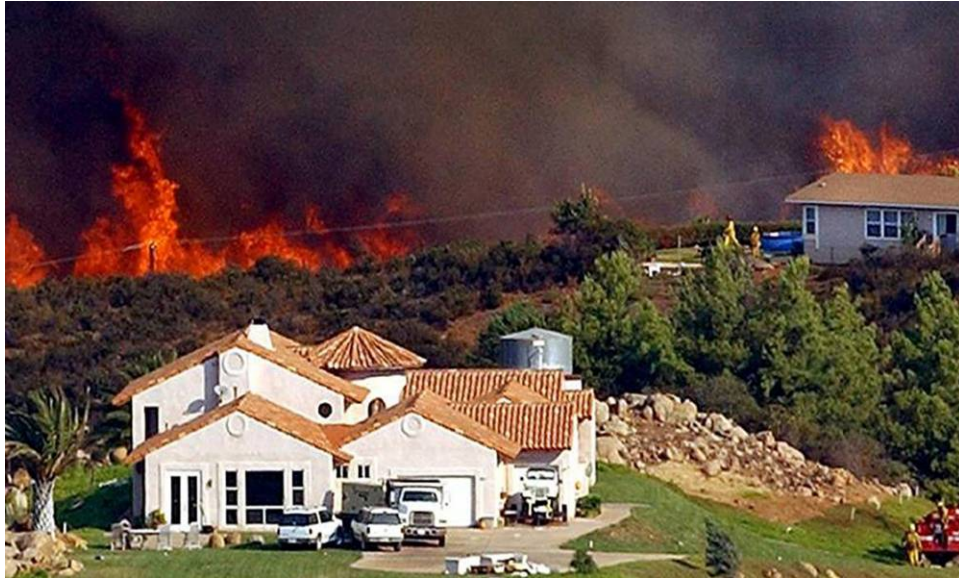
Figure 17: Illustration shows fire characteristics associated with high-fuel density surrounding homes in one UWI area. Photo courtesy of R. Crawford.

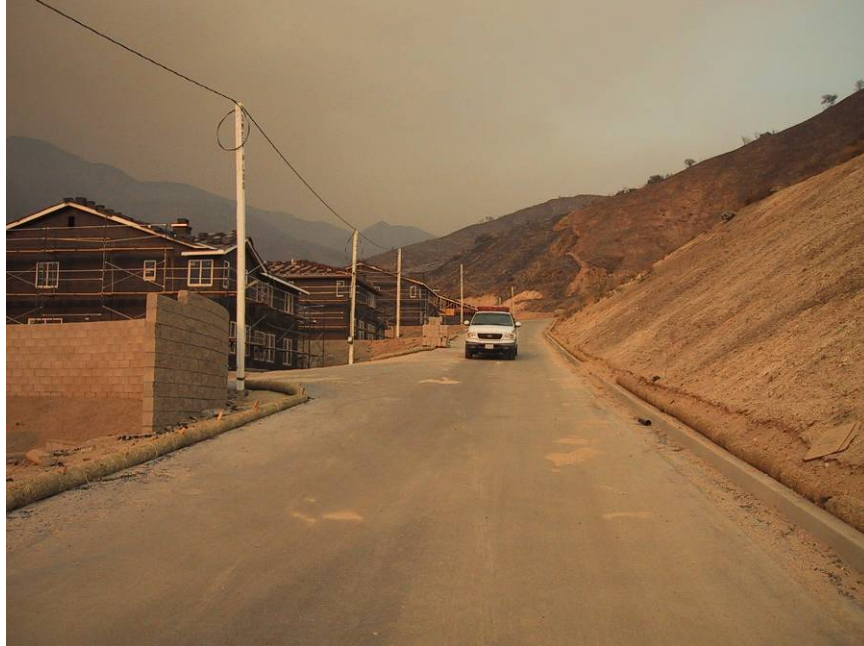
The preceding performance can be compared to the performance in the East Highlands Subdivision in San Diego County, which was still under construction at the time of the fall 2003 fires. In that case, there were no structures lost (even though some of the unfinished homes were surfaced with exposed building paper), at the time of the 2003 fires. This success was due to building placement, use of appropriate materials, and good pre-planning from a fire safety perspective.

Figure 21: Housing tract under construction during fall 2003 fires. Note fire damage to surrounding areas, available defensible space and fire deflection walls. Photo Courtesy of R. Crawford

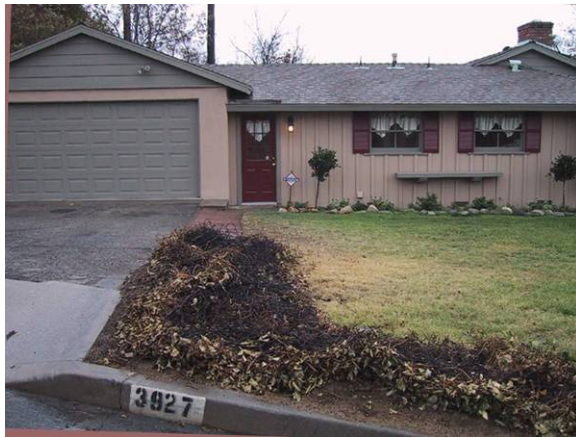
Figure 24: Single-family dwelling. (Photo courtesy of R. Crawford.)

In figure 24, a single-story wood sided dwelling is shown, which was built and maintained with a high level of defensible space. What can be seen is that restricted areas of combustible vegetation remote from the structure, while having burned, did not have an impact on the home's survival.

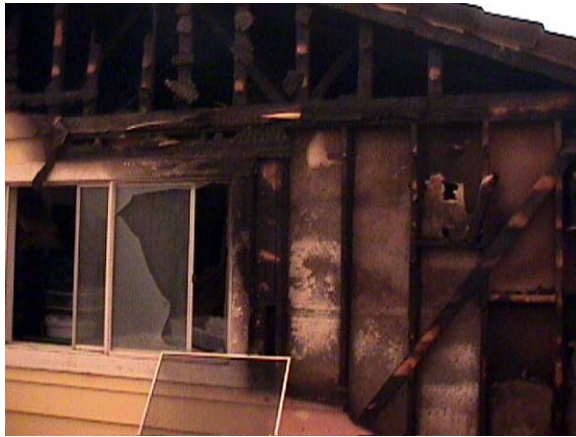
Figure 26:Ref Cedar 1009

In figure 26, burning external objects attacked this dwelling in the area toward the lower right of this photograph. Wood siding ignited and eventually burned through and, in addition, single- glazed windows broke and fire spread occurred either through attic gable vents above a window or possibly at frieze blocking. This is corroborated by loss of siding materials enclosing the attic area.

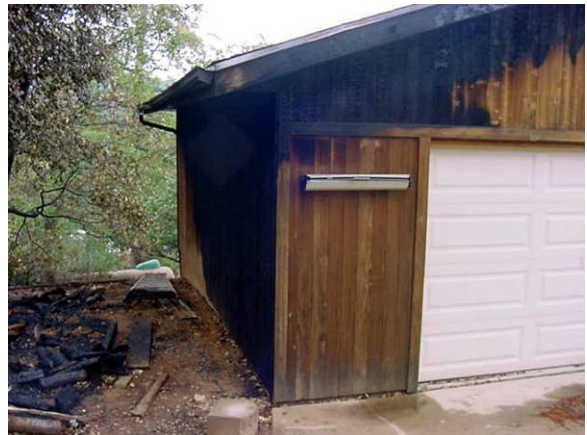
Figure 27: Ref Cedar 9081.

In figure 27, fire spread to materials stored adjacent to the wood siding. The debris suggests that a wood pile may have been located adjacent to this building and that, flaming as from a brand, began there. Next the wall adjacent to the wood pile ignited causing subsequent ignition of building eaves and possibly nearby brush. Due to intervention efforts and lack of spread to the interior of the building in the initial phases of the fire, this structure was not lost.

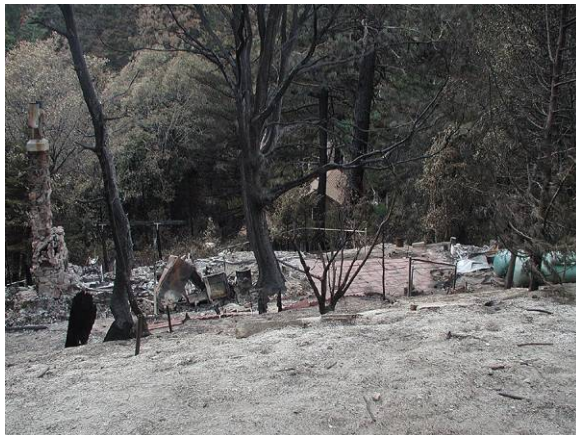
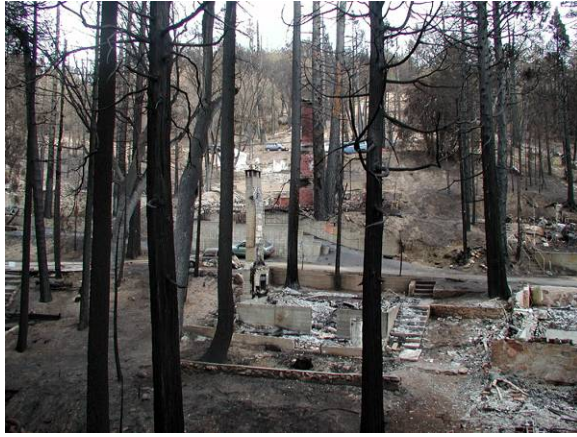
In figures 28 and 29, fire spread from building site to building site assisted by heavy brush, site topography and a lack of defensible space. The combination of these factors led to destruction of clusters of homes.

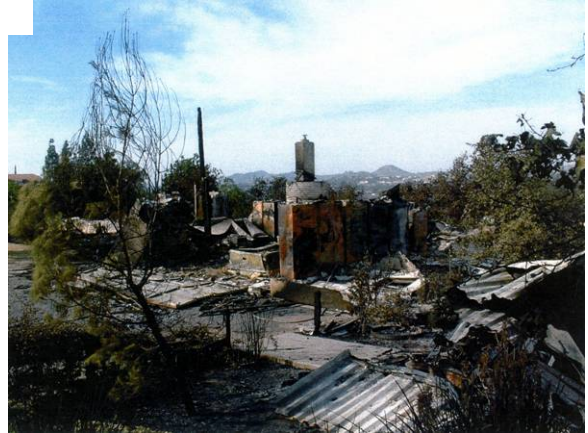
Figure 30: Ref Paradise 121

The residence seen in figure 30 included a tile roof and stucco walls and was completely destroyed in the Paradise fire. It included 15 ft. of defensible space. However, based on available information, an absence of burned vegetation in the direct vicinity of the residence, as well as the presence of an undamaged home at the left rear of the photograph, suggest that the damage to this residence was the result of flying brands or embers.

Figure 22: Based on the absence of burned vegetation in the direct vicinity of the residence, as well as the presence of an undamaged home at the left of the photograph, the damage to this residence was the result of brands or embers. Reference: Paradise 121.jpg

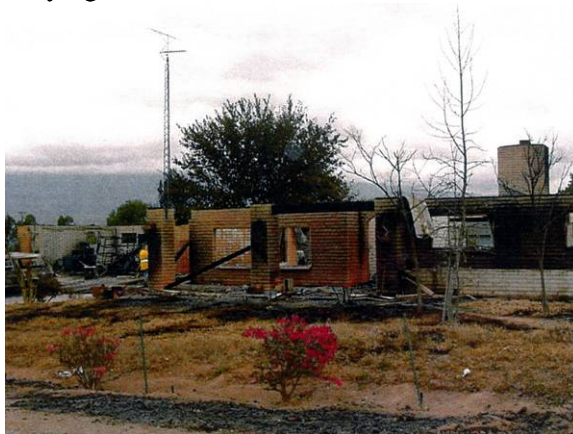
Figure 31: Ref Paradise 201

The home seen in figure 31 was also destroyed in the Paradise fire. The dead grass in the immediate vicinity of the home as well as several trees, provided a ready fuel bed for embers or brands. The collapsed tile roof and non combustible walls indicate that embers became trapped in the eaves or attic space then ignited the residence from

the inside.

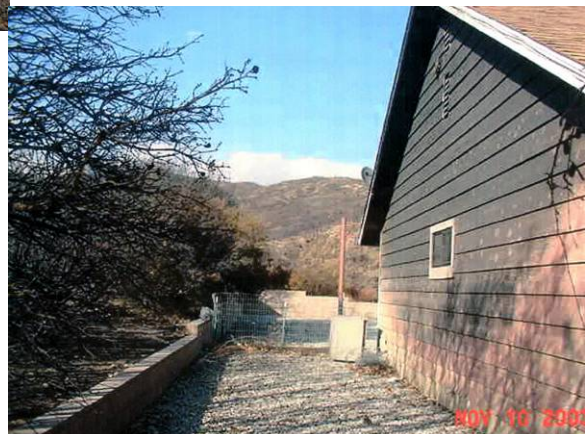
Figure 32: Ref Old 1a

Figure 32 and 33 are particularly interesting in that they illustrate the benefits of adequate defensible space, properties of combustible siding and how such siding can respond in the presence of strong radiative heat transfer. These photos also demonstrate how the chain of events potentially leading to destruction of a particular building will not be completed if a single element is missing.

Figure 32 shows the gable end of a one-story wood clad ranch house, which facing into a growth of burning manzanita – chemise brush became charred but did not ignite. An important factor here was the defensible space between the brush and the building and the essentially complete absence of plant materials on the ground. The charred area/radiation pattern is reflective of the vertical fire plume, which had been present during the incident.

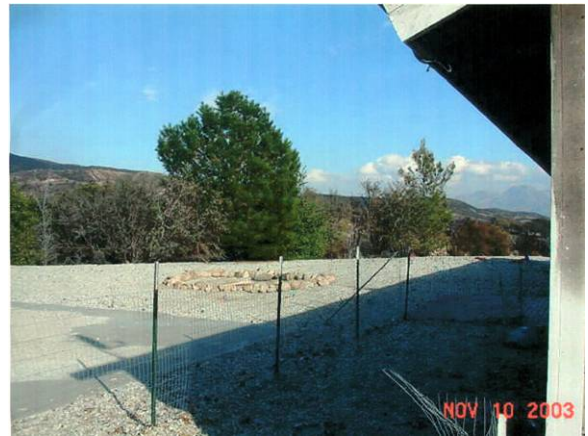
Figure 34: Ref Old 1 c

The photo in figure 34 illustrates the impact and size of defensible space in the rear of the home.

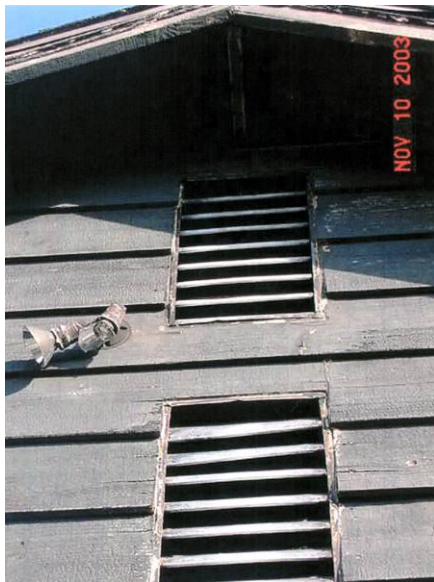
Figure 35: Ref Old 1 d

The photo in figure 35 shows the condition of gable and vents, which, in the presence of wind driven burning brands would have been expected to lead to ignition both at the charred wood surfaces and possibly within the attic space. The absence of ignition of this preheated wood suggests that no materials to pilot ignition at the wood surface were present. That role that would normally be fulfilled by airborne brands and/or burning embers.

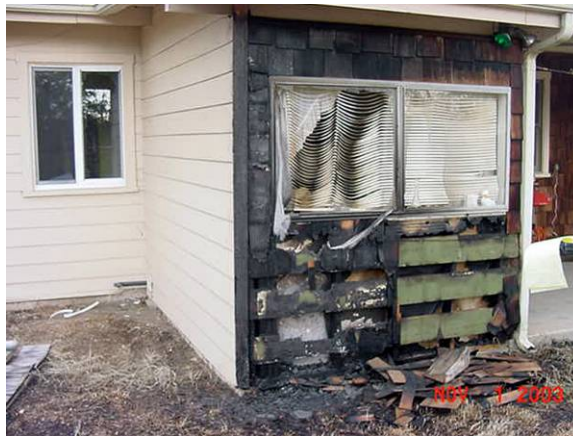
Figure 38: Ref Cedar 6069

In the example seen in figure 38, a burning brand or ember ignited the wood shingle siding causing vertical flame spread, fracturing the window glazing and eventual burn-through of the steel siding. Adjacent walls to the left, most likely of aluminum or steel siding did not ignite and illustrate comparative performance.

Figure 35: This photograph demonstrates the difference in performance between different cladding materials. The area on the left appears to be clad in aluminum or steel siding, which remained intact. The area on the right, however, was clad with wood shake, which did not withstand ignite. There is dead grass surrounding the residence, which contributed to the fire, and most likely ignited the wood shake. * Reference: Cedar 6093.jpg

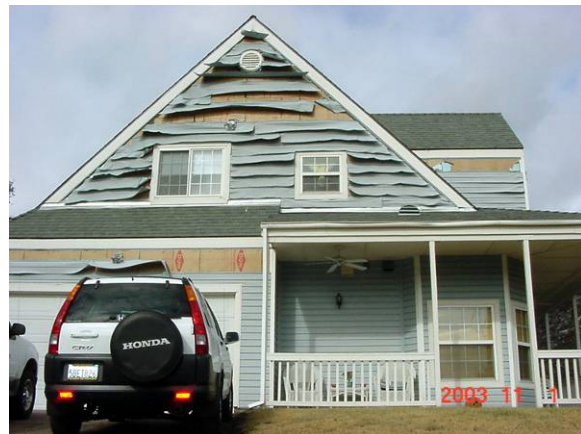
Figure 39: Ref Cedar 15002

In the case seen in figure 39, the response of thermoplastic

vinyl siding installed over polystyrene insulation can be seen. In the absence of sufficient heat flux and or brands to ignite these materials, the siding materials melted and deformed.

Figure 34: This home did not ignite, but convective and radiant heating by the fire front occurred. This caused the warping of the siding on the exterior cladding. Reference: Cedar 15002.jpg

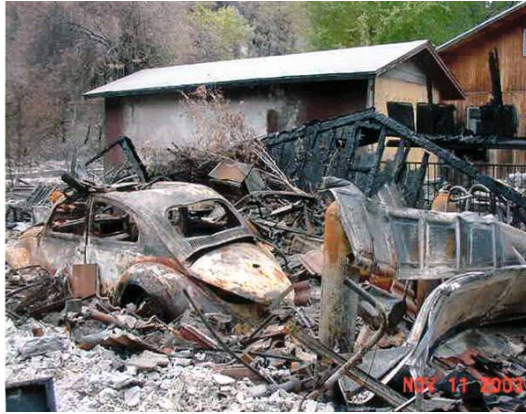
Figure 40: Ref Grand Prix 15a

In the loss shown in figure 40 and 41, ignition of the building began in the left foreground, which included the garage, and then spread to the stucco clad building to the right. The fire performance of that stucco wall is depicted in the figure 40.

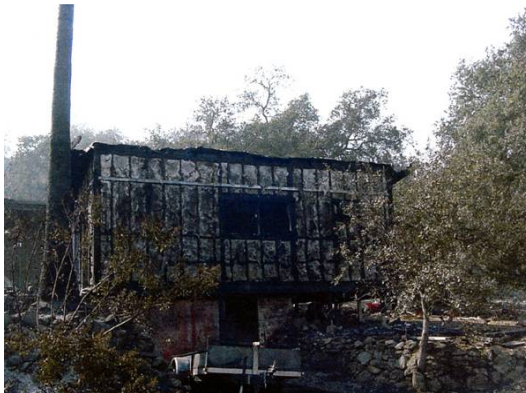
Figure 42: Ref Paradise 416

The photo in figure 42 illustrates the consumption of a combustible building cladding enhanced by the presence of nearby untrimmed brush.

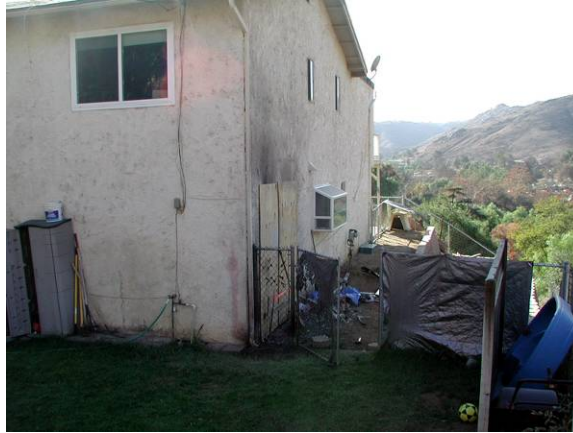
Figure 43: Ref Cedar 108-162

The photos in figures 43, 44 and 45, show in sequence, the remains of an opening for a glazed sliding door (covered after the fire by plywood)

Figure 26: In this photo, sooting from hot gases exiting the sliding door is apparent above the boards currently sealing the residence. The abundance of healthy grass in the foreground of the photo suggests that the fire was not ground-based, but rather brand- or ember-based, followed by structural failure of the window.
Reference: Cedar 108 pix 162.jpg

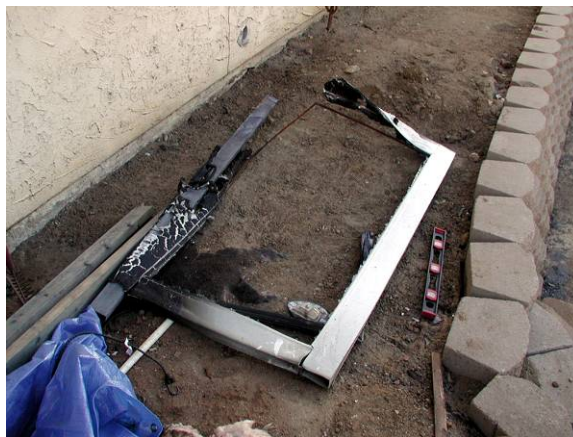
Figure 44: Ref Cedar 108-161

which was ignited by nearby combustibles which themselves had been ignited by a flying brand. Interestingly, one can see the intact tempered safety glass used in the original sash, as well as the burned vinyl frame, which failed thus allowing fire spread into the building as seen in figure 45.

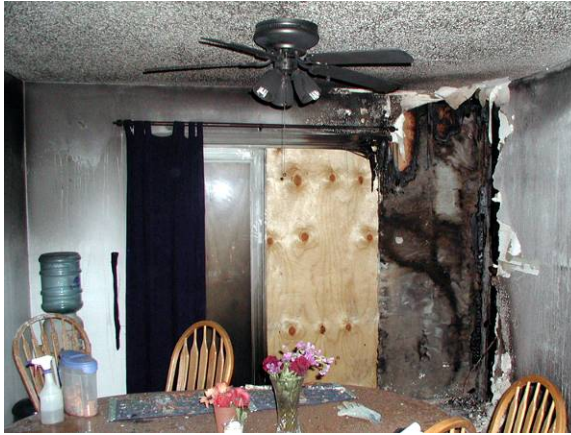
Figure 45: Ref Cedar 108-164

Figure 27: This photo depicts the interior of the same residence behind the boards shown in the previous photograph. The incoming fire appears to have ignited a drape that hung on the right side of the sliding glass door, which then led to ignition of other items in the interior of the home. Cedar 108 pix 164.jpg

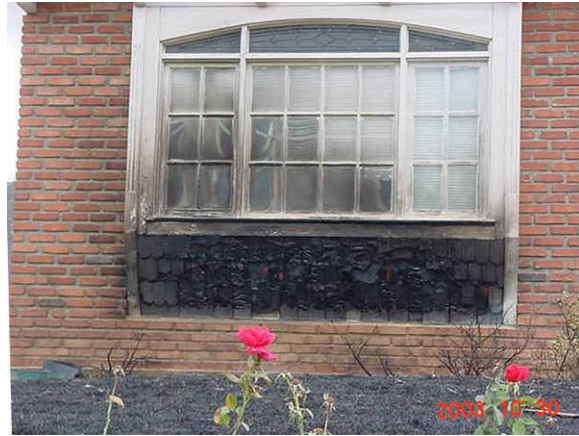
Figure 46: Ref Cedar 1034

The photo in figure 46 shows the fire performance of wood shingle trim on the side of a brick clad building, which was ignited by brush below the window. It is unclear whether or not fire breached the windows themselves.

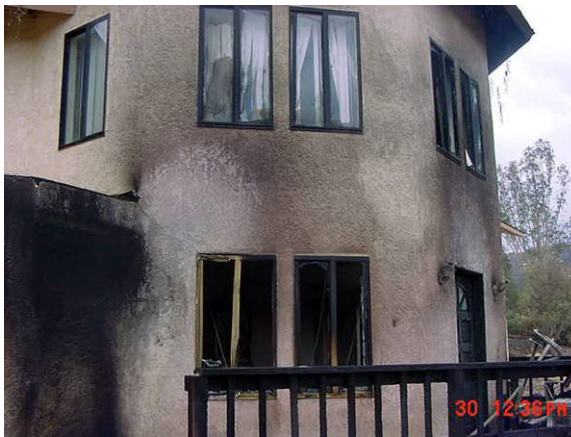
Figure 47: Ref Cedar 3018

Figure 47 depicts fire entry through failed glazing in a stucco wall.

Figure 28: This fire initiated at ground level, but the heat was sufficient to break through the window glazing, allowing for entry into the residence. Note the intact brush in the background of the photograph. *
Reference: Cedar 3018.jpg

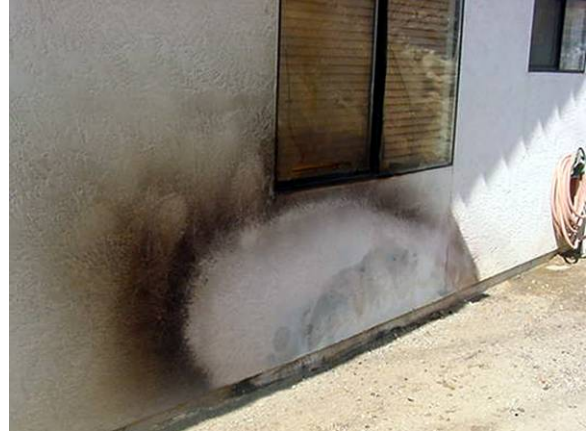
Figure 48: Ref Cedar 5093

The photo in figure 48 depicts the outline of materials which burned along a stucco-clad wall below a double glazed window opening. In this case the glazing functioned sufficiently to prevent fire from entering the building and did not fail completely, although exterior glazing layers appear to have been compromised. This illustrates a positive attribute of multiple glazed windows.

Figure 29: This burn pattern was produced by a light combustible in close proximity to the residence, which either self-extinguished or was extinguished before it could completely penetrate the window glazing. Note that one layer of the window glazing is cracked, but that the blinds behind the window do not appear to be warped or melted significantly. * Reference: Cedar 5093.jpg

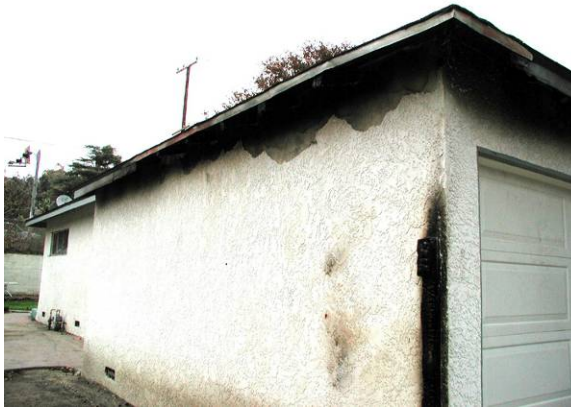
Figure 53: Ref Old 21-27

The photo in figure 53 depicts fire spread along an open eave design which is part of an attached building garage.

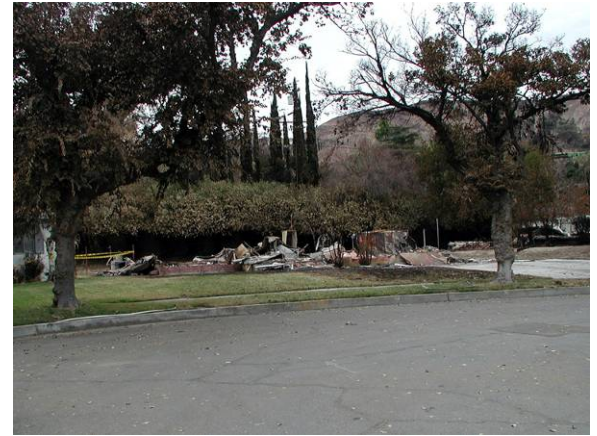
Figure 54: Ref Old 2125

The remains of a ranch home can be seen in figure 54. Note the virtually intact garden on three sides of the home. Eyewitnesses observed burning brands entering the attic of this home, causing its total destruction.

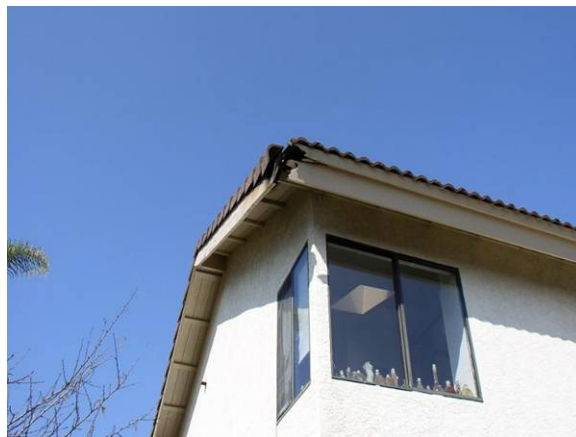
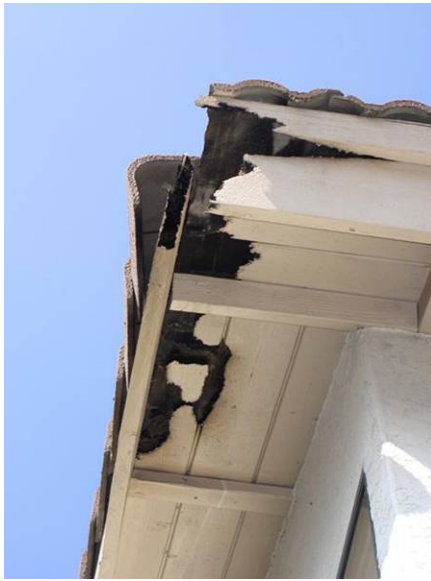
Figures 55 and 56, (overall view and close up) show an open eave design in conjunction with a tile roof which permitted passage of burning embers into a roof deck area. Ignition occurred in this case, but the resulting fire did not destroy the building. This illustrates a problematic aspect of the study of such ignitions which have the potential for creating sustained building ignitions but where, in some cases, only localized fire growth occurs.

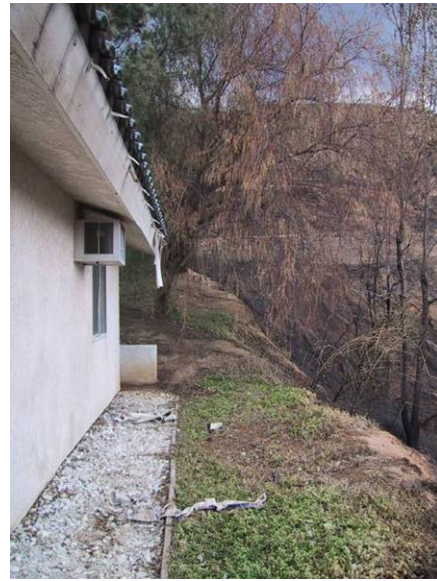
Figure 57: Stucco-covered soffit & eave design. Photo courtesy of R. Crawford.

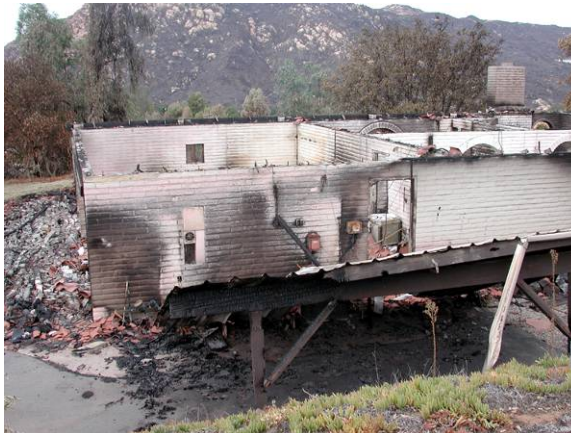
Figure 58: Ref Cedar 67-1124

Figure 58 shows the fire performance of an attached carport roof deck. This fire was observed to spread from a deck area at photo left, igniting materials under this roof deck, and causing spread into the building through a glazed opening.

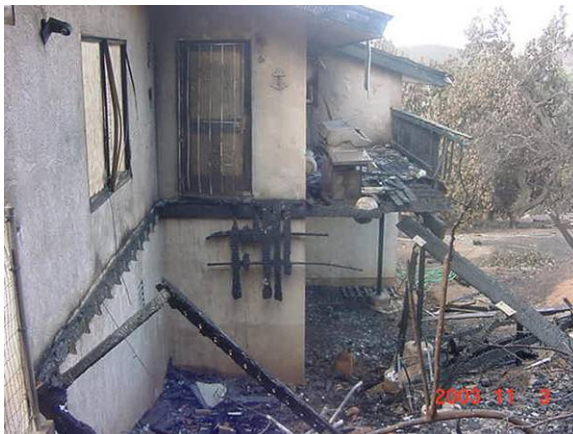
Figure 59: Ref Cedar 2106

Figure 59 illustrates the results of ignition of a wood deck due to materials burning from below. The burning of the deck created an avenue for window breakage and direct fire entry into the stucco clad building.

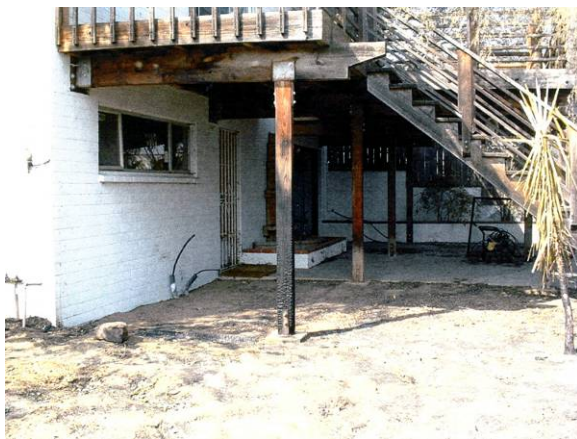
Figure 61: Ref Paradise 111

Figure 61 illustrates how a fire at ground-level attacked building elements, including a stairway going to a second-level. However, this fire burning at ground-level did not breach the first-floor openings of the building.

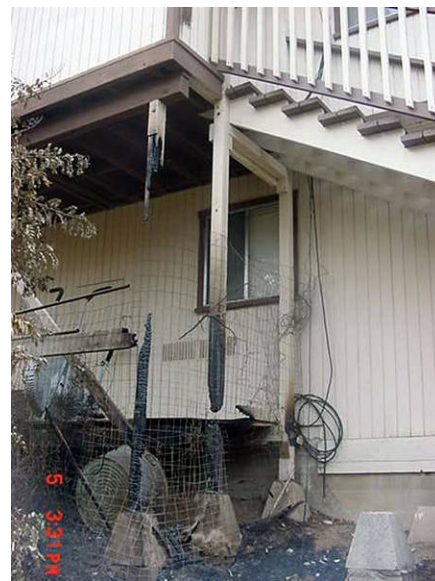
Figure 60:Ref Cedar 5101

The photo in figure 60 depicts discontinuous burning of a deck constructed with a vulnerable underside and fuel present.

Figure 9: The fire was a ground fire that moved to the underside of the deck, then burned its way upward. Note the extensive damage to the vertical beams; this implies that the fire was burning for a while before either self-extinguishing or being extinguished. * Cedar 5101.jpg

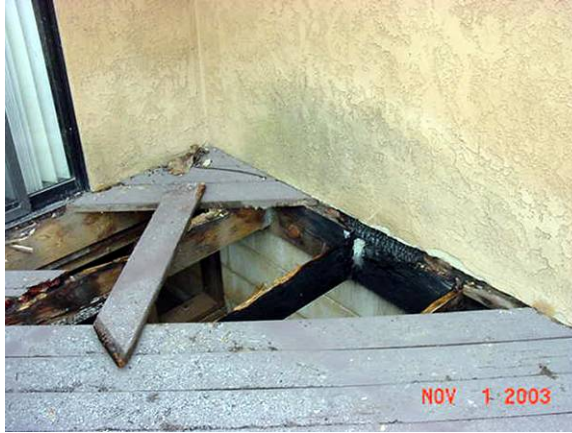
Figure 62: Ref Cedar 6097

Figure 62 depicts a lack of vertical fire spread from a wood deck composed of tightly fitting wood boards whose particular design prevented spread to the upper surface of the deck and associated building components such as the glazed opening at photo left.

Figure 10: The fire began under the deck and moved laterally, charring the wood members underneath. The fire then either self-extinguished or was extinguished. * Reference: Cedar 6097.jpg

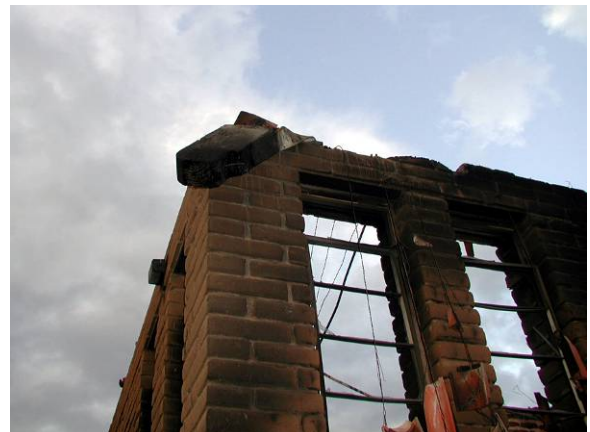
Figure 64: Ref Grand Prix 34a

Figure 64 shows the remains of a brick structure with heavy wood beams, which was observed to have embers, which were sucked into the attic spaces prior to building ignition. The overall view of the building can be seen in figure 65.

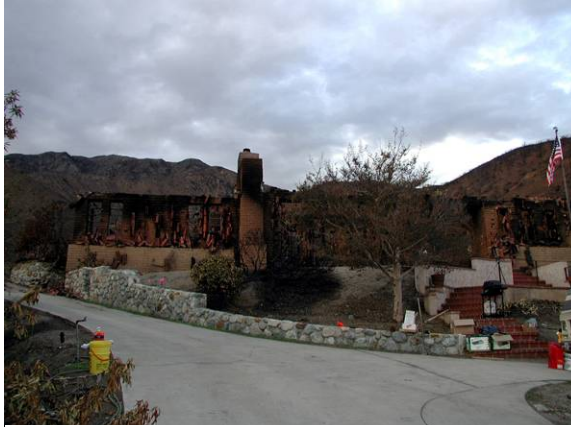
Figure 65: Red Grand Prix 34b

Figure3: Overall view of residence. Note remaining green shrubbery in front of the residence, which supports this loss being caused by an ember. Grand Prix 34 front.jpg

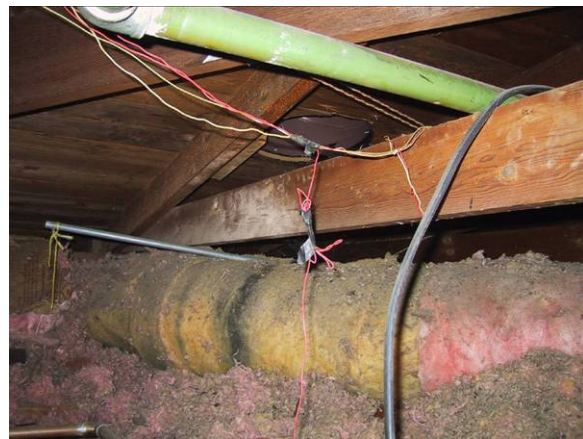
Figure 66: Attic are below turbine vent. Courtesy R. Crawford.

Consistent with observations of embers being drawn into at-risk UWI structures, numerous witnesses specifically reported that spinning turbine ventilators - designed to create negative pressure within attics - encouraged fire involvement there. In figure 66, burned embers were located in a building attic directly beneath such a wind turbine. Apparently the presence of noncombustible insulation prevented ignition in this attic space.

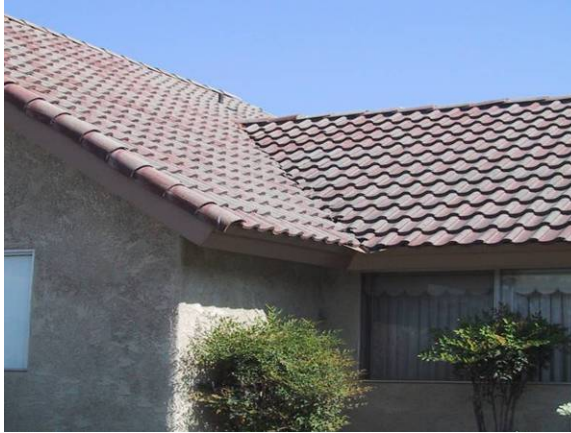
Figure 67: Tile roof system. Photo courtesy of R. Crawford

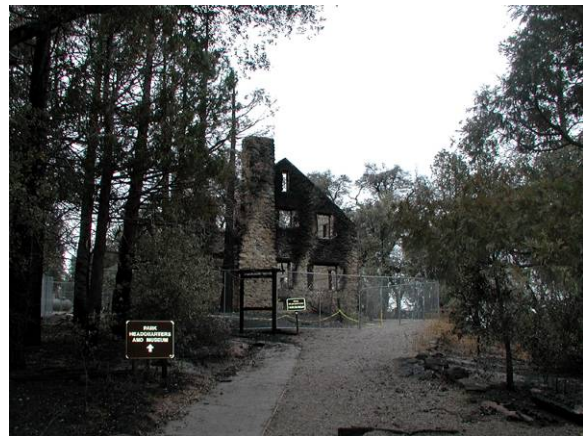
Figure 68:Ref Cedar 105 117

Other examples of roofing assemblies include figures 68 and 69 which reflect the not unexpected behavior of an old-style wood shake roof near a state park building.

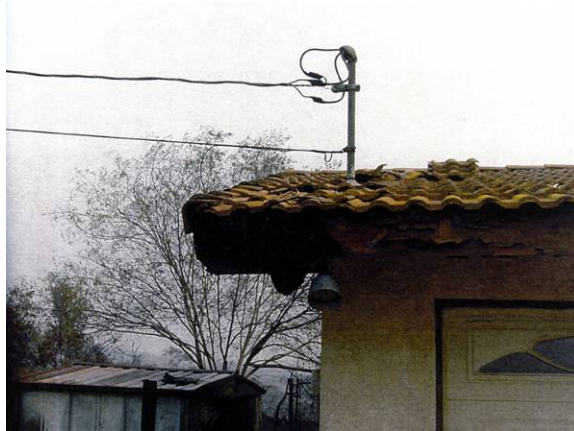
Figure 70: Ref Paradise 410

Figure 70 depicts fire involving a roofing system based on noncombustible tile, which was subject to the intrusion of burning brands and/or embers.

Figure 33: Embers' effect on the roof of the structure in the foreground, causing ignition under the eaves. Reference: Paradise 410.jpg

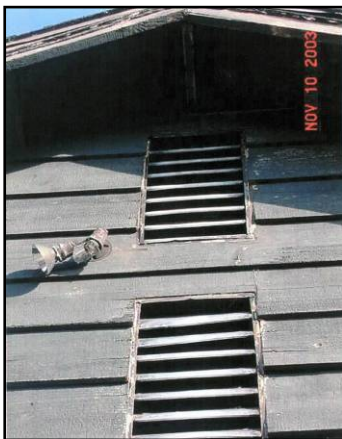
Figure 7: This photo depicts the attic/gable end vents, which sustained heating but did not sustain ignition by either brands or embers. Reference: Old 1 Vent.jpg

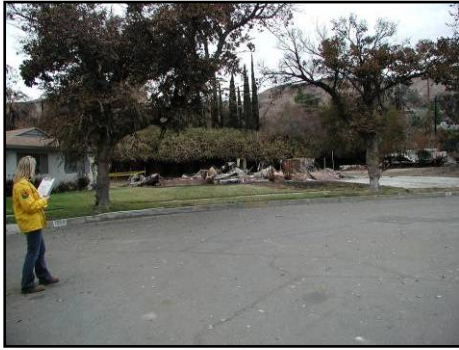
Figure 14: Residence completely destroyed. Note the green grass and the healthy trees in the immediate vicinity of residence; these indicate that a brand or embers, as opposed to direct flame impingement, started the fire. Reference: Old 21 25.jpg

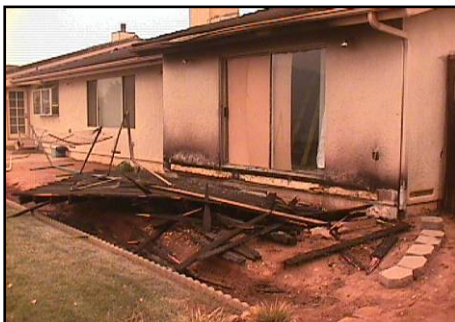
The next case, figure 25, is a stucco clad home, with limited combustible vegetation surrounding it. The home was fire damaged, but not destroyed when an exterior wood deck was ignited by a burning brand. While building areas above the deck were fire

Figure 16: : This fire began at the deck, probably by a brand. Destroyed the deck and window glazing adjacent, allowing entry of the fire into the residence at glazing opening. Note the well-managed landscaping. Reference: Cedar 1003.jpg

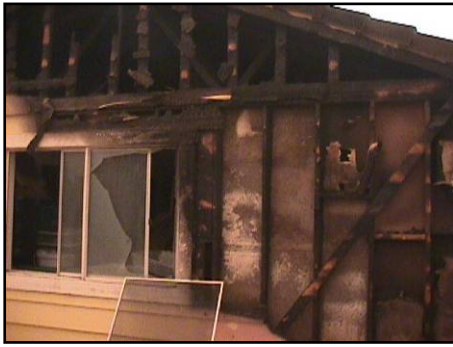
Figure 17: This fire most likely began on the lower right side of the photograph, where it ignited combustible exterior cladding, then moved upward consuming eaves and breaking the single-pane glazing, where fire then appeared to enter the residence through the opening. * Reference: Cedar 1009.jpg

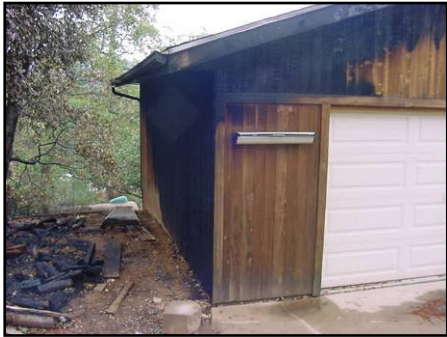
Figure 18: The fire moved from the left of the photograph to ignite the building, most likely igniting a woodpile on the side of the home initially. The woodpile then ignited the side of the wood-clad structure, sending heated gases and embers into the eaves, which spread the fire along the section of the structure. Note the charred area along the top of the structure. * Reference: Cedar 9081.jpg

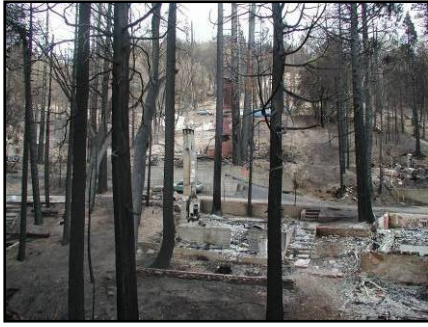
Figure 20: This photo depicts the overall effects of the fire in this area, showing extensive damage to all structures in the area. Under this type of fire scenario, enhanced structural features will assist minimally in preventing destruction, but in areas with a high fuel density, ignition may still occur. Note the proximity of the trees and vegetation to the destroyed homes. Reference: Old 10 #8.jpg

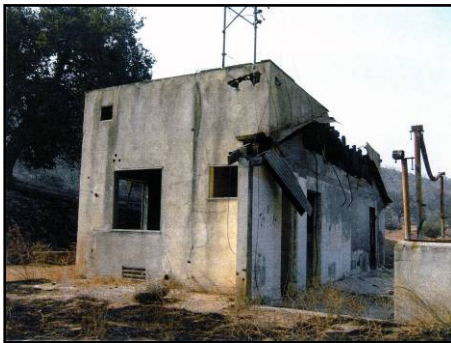
Figure 24: This photo depicts a structure that has been severely damaged by the fire. The top right section of the roof and upper wall is destroyed, suggesting that the fire may have begun from a brand or ember either igniting the roof or becoming trapped underneath the eaves on the front of the structure, igniting the wall and eventually the roof. Reference: Paradise 507.jpg

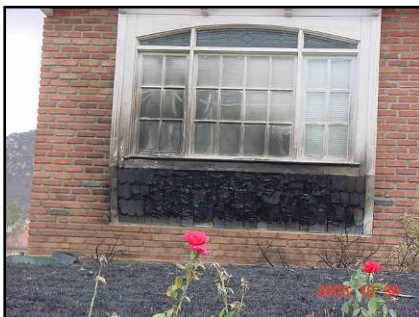
Figure 25: The fire appears to have moved along grass, also igniting ornamental plants. These ignited wood shake trim underneath the window. The heat of the wood shakes burning was sufficient to warp the blinds behind the window, but it does not appear to have cracked the window glazing. In other structures, the burning of this combustible window trim would have cracked the window glazing, possibly allowing entry into the home and leading to complete destruction of the residence. * Reference: Cedar 1034.jpg

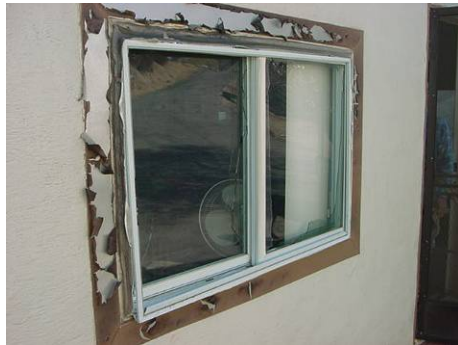
Figure 30: This photograph depicts fire-damaged window trim with cracked window glazing. The glazing is double-pane, which prevented the fire from entering the residence as the window frame burned. * Reference: Cedar Saved 212

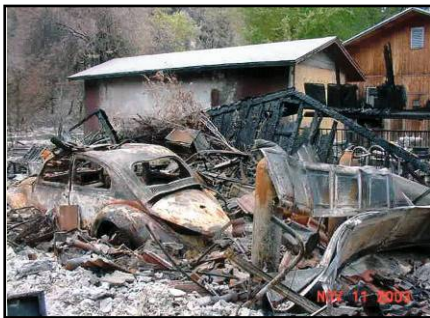
Identifier: Grand Prix 15			
Structure Condition	Total Loss	Roof Covering/Assembly	Concrete Tile
Construction Type	Type V Not Rated	Wall Construction	T-111
Prevailing Vegetation Type	Heavy Ornamental	Window Glass Type	Single Pane
Property Line Setback	0-5 feet	Window Frame Type	Aluminum
Decade Built	1980	Vents	Louvers on both sides
Area of Fire Origin	Exterior Wall	Eave Construction	Boxed
Form of Ignition	Direct Flame	Defensible Space	0-29 feet

Figure 36: The home in the foreground was completely destroyed. Two nearby structures, however, appear only to have suffered radiant heat damage as well as some direct flame damage, but no ignition. Reference: Grand Prix 15.jpg

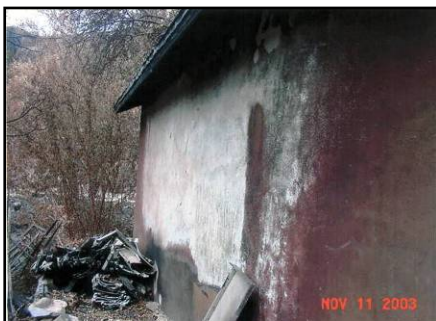
Figure 37 This photo depicts a closer view of a wall adjacent to the destroyed structure. This wall suffered surface damage only. Reference: Grand Prix 15 Close.jpg
